Restoring Postwar Heritage

preservation technology
dossier 8
August 2008

Conservation of Stone Facing in Modern Italian Architecture

Sergio Poretti, Rinaldo Capomolla,
Tullia Iori, Stefania Mornati and Rosalia
Vittorini

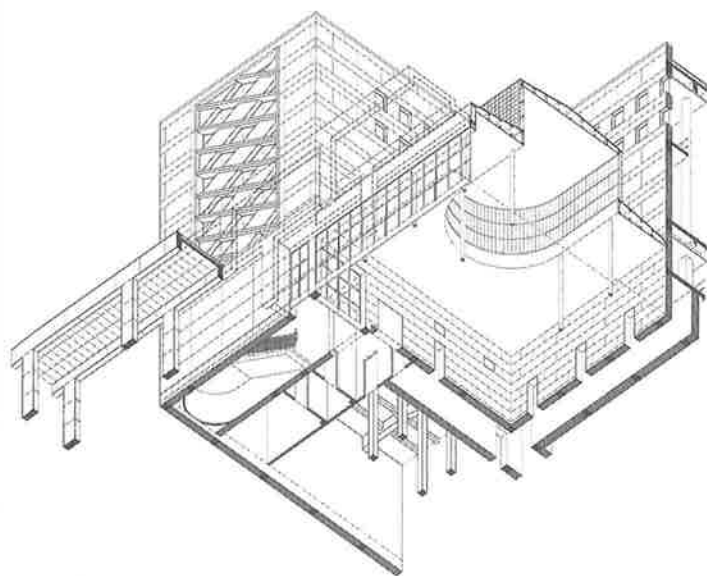
Post Office Building: Axonometric drawing (Drawing: T. Iori)

The Palazzo delle Poste is faced entirely in travertine.² Violet porphyry from Predazzo was used to face the portico to make it stand out materially and chromatically from the main nucleus. The facing consists of thin slabs (three to four centimeters thick at most), applied directly to the mixed-style construction of reinforced concrete and traditional masonry. This is an unusual method that had not yet been experimented with at length at the beginning of the thirties. The slabs were affixed to the main nucleus of the building by traditional building techniques. Every slab rested on the one beneath it and was joined to the wall by hooks made of reinforcing rods of galvanized iron.

The solution adopted for the portico was far more innovative. There, the thin slabs were joined to the reinforced concrete structure by means of invisible cramps and eyelets. Facing of the pillars was executed by resting the slabs one above the other and using galvanized iron reinforcing-rod hooks, previously inserted into the structure, to prevent the slabs from falling over. Eight hooks suspend the much smaller horizontal slabs from the beams and floor system intrados. The eyelets were necessary to affix the vertical facing to the architrave, which had no resting point. Metal spikes (inserted into conical lodgings half the width of the slab) were mounted on the slabs to allow them to be joined to the main structure.

Soon after the building was completed, the portico slabs began to detach. The few fixed anchoring points proved insufficient for the large dimension of these slabs (2.15 meters long and 1 meter wide), which were also rather hazardously shaped to reduce the discontinuity in cuts. Diverse thermal dilations between the structure (which had no joints) and the porphyry facing led to stress that could not be absorbed by the metal reinforcing rods.

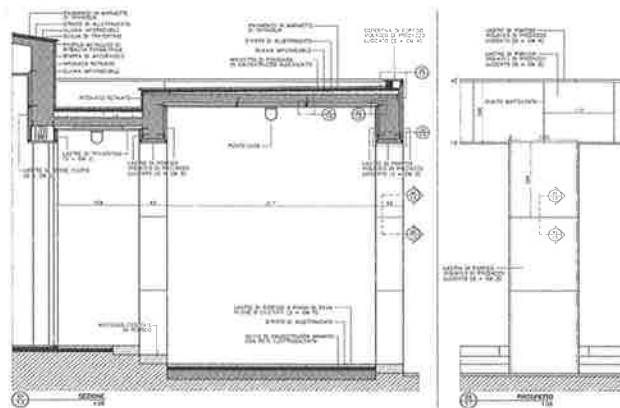
Post Office Building: Conservation Project. (Poretti 2005)

had to be updated. The slabs were to be affixed only to the structure and not joined to each other in order to permit free thermal expansion. This was implemented by adopting a stainless steel framework that joined every individual slab to the pillars and beams with double expansion anchors. In this way, every slab was held in place independently of the others and was slightly distanced from the structure itself.

suggested by Libera himself (in his 1943 sketches) was adopted: The dimension of the slabs on the main façade was halved and standardized to four centimeters in width.³

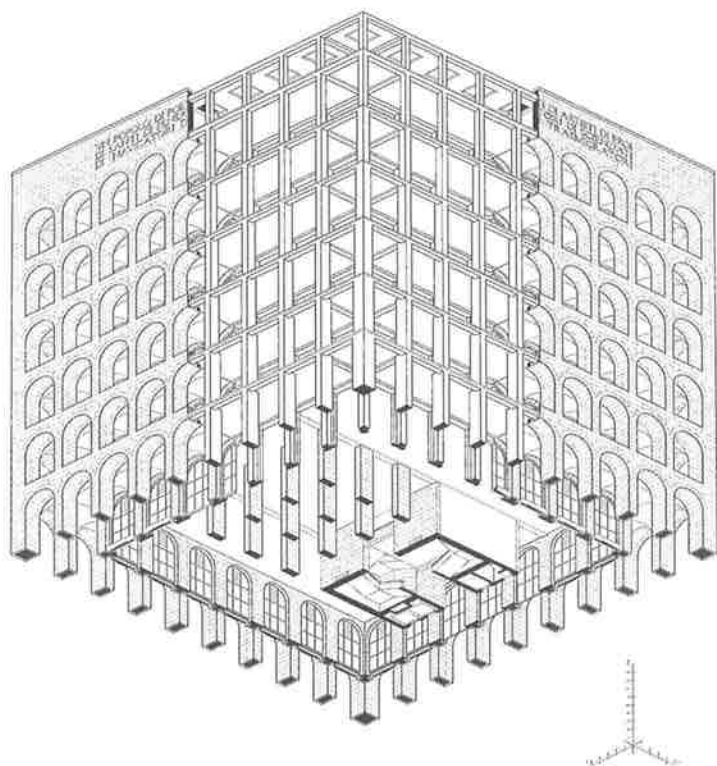
Palazzo della Civiltà Italiana: Axonometric drawing. (Poretti, 2005)

The Palazzo della Civiltà Italiana has an elementary configuration.⁵ It is a gigantic cube perforated by 216 round arches, repeated identically on all four facades, nine per floor on all six floors. The stability of the building is based on its reinforced concrete framework. The framework, however, is complemented by traditional brick masonry on the inside and the external travertine facing. The inner masonry "filling" varied greatly in width (from 3 to 97 centimeters) depending on the progressive reduction of the pillar width in relation to the building height.

During construction, the brick "filling" was raised together, step-by-step, with the travertine slabs, often creating a single heterogeneous but indistinguishable unit. The slabs were adjoined to the brick masonry by means of steel rods. Floor by floor, this elaborate brick and stone structure acquired its own static autonomy, absorbing the load of the travertine ashlar on the archivolt (usually about 15 to 20 centimeters wide), as it was built not only to imitate the arches but also to conserve its static drive. The 17-cm-thick frames that upheld the arches were not completely self-supporting, but were also anchored to the pillars and the floor system above by iron and steel rods.

The complex interactions between the facing and the main supporting structure and the loss in efficiency of the joining cramps have led to the present state of deterioration. This does not, however, present any generalized slab detachment as occurred in the buildings faced with thin slabs. In this case, the deterioration entails local ruptures and loosening of individual elements (mainly the corner slabs due to the load pressure).
